► CIPP LINING FOR NSF CERTIFIED TRENCHLESS TECHNOLOGY REPAIR

Collins Canal Repair

Miami Beach, FL

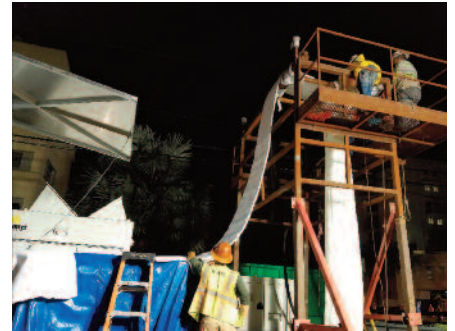
Inversion of the 20" Diameter Potable Water Lining Tube

In July, Lanzo accessed, bypassed and lined the 20-inch cast iron pipe with an NSF 61 Certified CIPP liner. The reinforced liner was impregnated with a potable water grade Epoxy where no shrinkage and excellent adhesion insured pressure test compliance. The closure assembly utilized standard mechanical joint fittings.

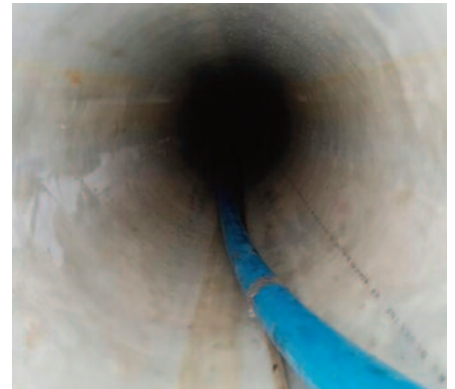
Post Inspected Defect Free and Ready for Testing

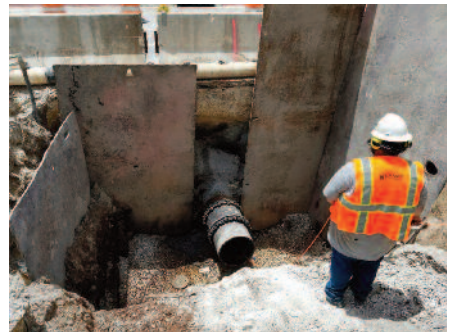
The Insertion Pit was minimal in size and utilized standard MJ assembly
